WILLIAM GRIFFIN AND BILLIE)	
GRIFFIN,)	
)	
Plaintiff,)	
)	
v.)	Case 1:21-cv-02818
)	
AMERICAN SELECT INSURANCE)	
COMPANY,)	
)	
Defendant.)

2 - DIAGRAM OF HOUSE AND PLUMBING SYSTEM

3 - DRAINAGE REPORT AND PHOTOS

PLUMBING REPORT

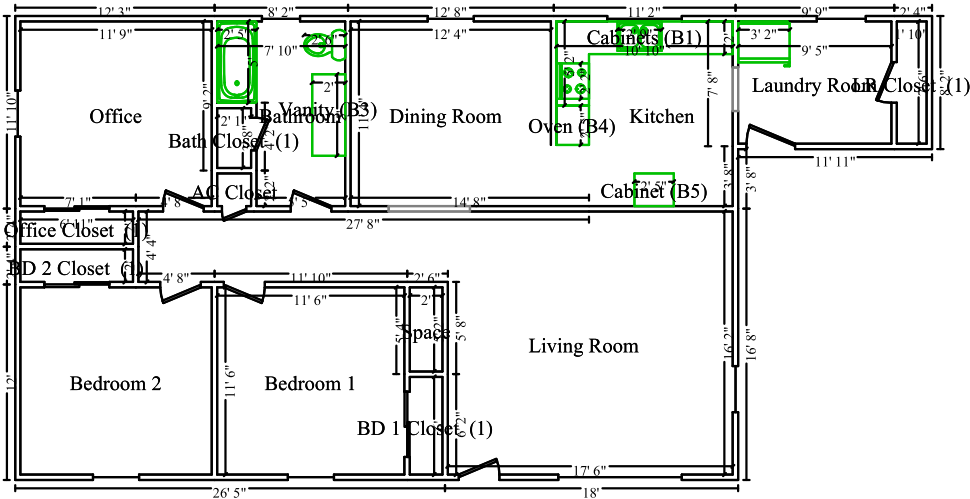
Main Level

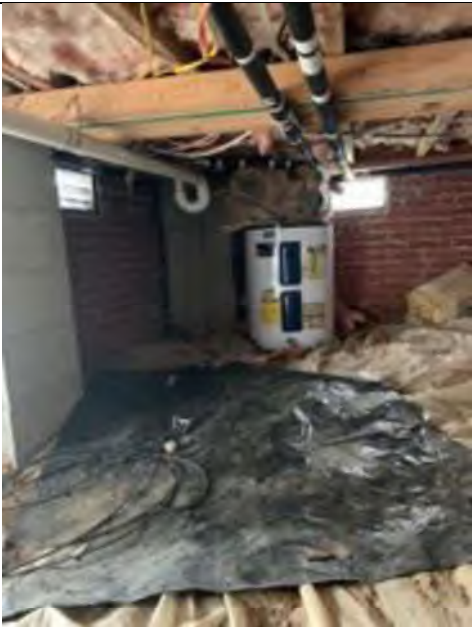
1.

The interior of the cast iron drainage line is extremely rough and jagged.

Only bathroom with Cast Iron. It was grooved and deteriorated and we recommend replacing the Cast Iron. Much of the piping is PVC throughout the rest of the home. Vent to Master Bathroom is Cast Iron and should be replaced.
